INVESTIGATION OF HIGH WATER TABLE  
TOWNSHIP OF FLAMBOROUGH  
REGIONAL MUNICIPALITY OF HAMILTON-WENTWORTH

ONTARIO MINISTRY OF THE ENVIRONMENT  
WEST CENTRAL REGION  
TECHNICAL SUPPORT SECTION

The Effect of the Valens Reservoir  
on Overburden and Bedrock Hydrology  
of the Valens Area

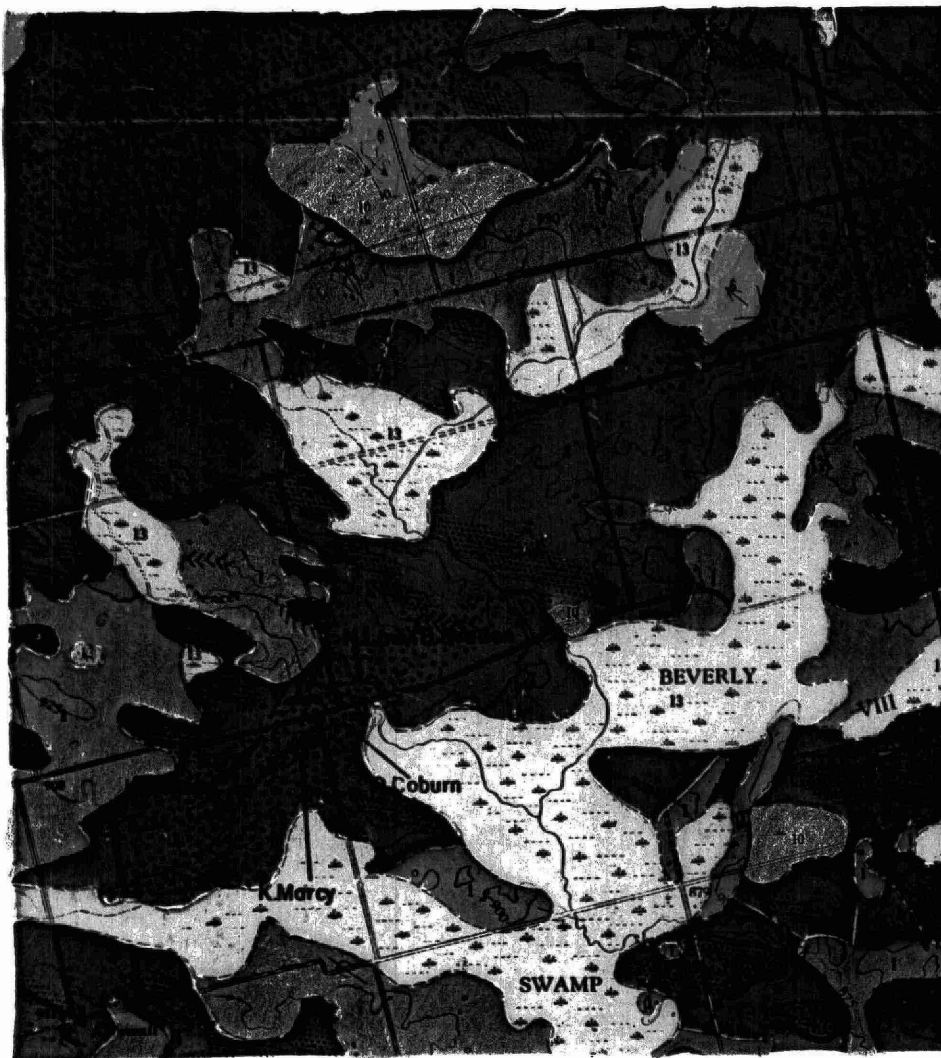
FIGURE 2  
Surficial Geology Map

The Pleistocene geology map No. 2029 of the Galt area (P. F. Karrow, 1961, Figure 2) indicates that the reservoir is situated on a shale and dolomite outcrop of Ordovician and Silurian age. The Marcy farm, along with most other farms in the immediate Valens area is located on the southern portion of the Moffat Moraine. The Moraine is comprised largely of Wentworth till varying from fine to coarse sandy till; the coarser textures containing cobbles and boulders. The bedrock surface in the area slopes generally from north to south reaching elevations of 950 feet in the vicinity of Highway 401 (five miles north of the study area) and approximately 700 feet (nine miles south of the study area) at Highway 5. The area of Spencer Creek, presently covered by the reservoir was likely a discharge area prior to the impoundment of water by the Valens Dam. Now, the impoundment acts partly as a recharge zone and provides for an increased hydraulic gradient to areas of lower elevation surrounding the reservoir.

It has been noted from the surficial geology map (Figure 2) that the Marcy, as well as the Law/Braden farms are located on the southern portion of the Moffat Moraine. Considering the physiographic location, the Valens area is situated in proximity to the Lake Erie/Lake Ontario Drainage Basin divide, (Figure 3). It appears from the topography and regional physiography, that prior to water impoundment, the Marcy wetland likely drained toward Spencer Creek. However it now seems that the ground water drainage gradient has been reversed since the impoundment of water by the dam, thus resulting in ground water flow from the reservoir, toward the Marcy and Mount farms. This causes perennial wet land in Mr. Marcy's case and the flowing well in the case of Mr. Mount (Figure 9).

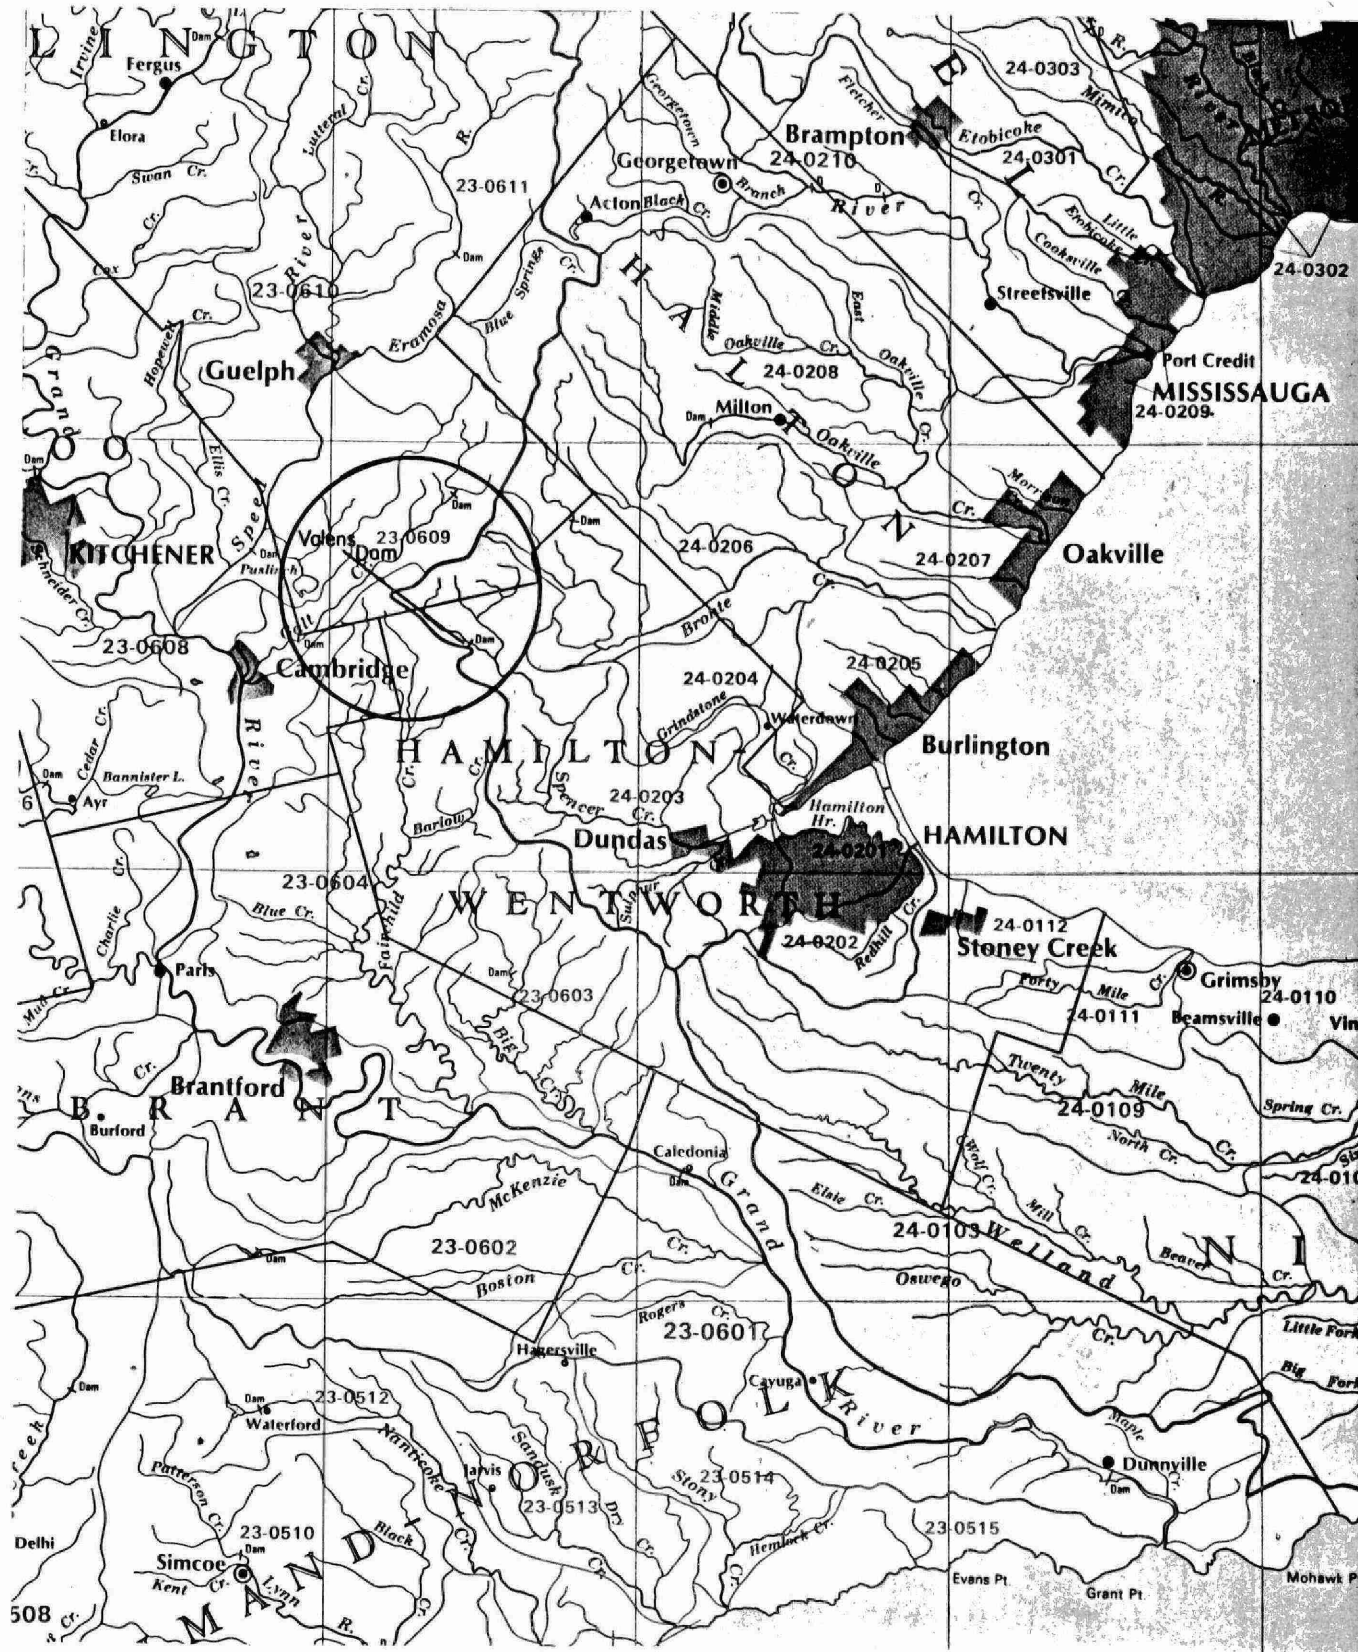
FIGURE 3  
Drainage Basin Map

From the map Drainage Basins in Southern Ontario (Map 3002-2, Figure 3), it is evident that the study area is situated on the Lake Ontario and Grand River-Lake Erie Drainage Basin divide. Overburden and surface water drainage, according to the natural physiographic characteristics and the drainage basin map, seem to be toward Spencer Creek (Figure 3). The reservoir at this physiographically strategic location, may have altered directions of water flow from the natural hydrologic ground water/surface water conditions.

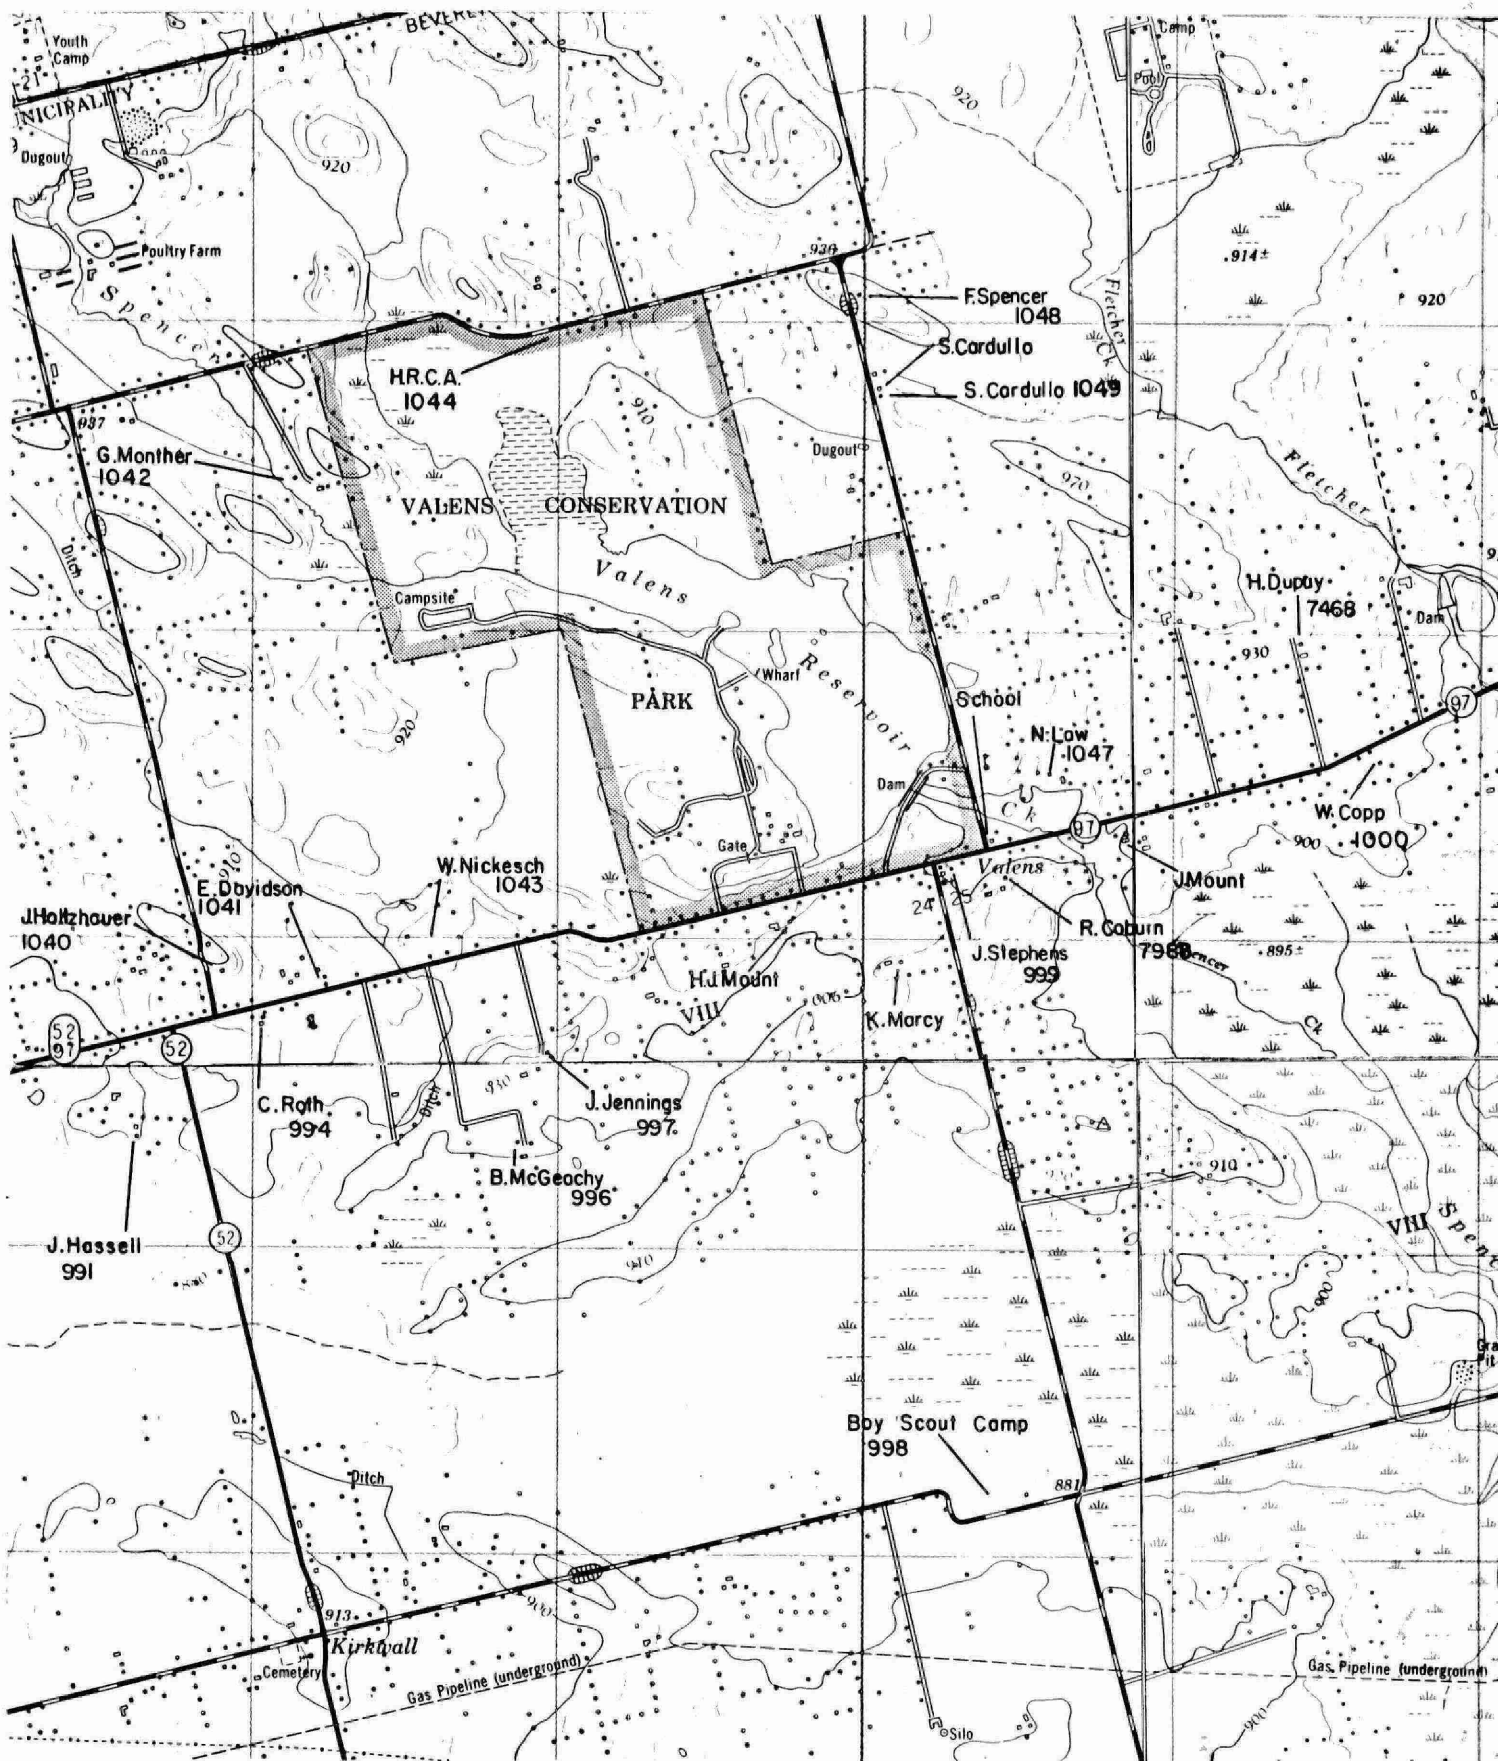
FIGURE 5  
Well Water Level Survey Location Map  
Scale  
1:25,000

The old school house drilled well on the corner of Highway 97 and Valens side road, was flowing during all our inspections of the study area (Figure 5). Residents will again corroborate that this well began flowing unceasingly since the impoundment of water by the dam. On June 3rd, the Coburn well was also observed flowing. This is a bedrock well and information from the water well record is summarized in the Appendix. Mr. H. J. Mount's old, abandoned dug well was observed flowing during inspections on May 12th, 1977 and also June 16th, 1977 when the elevation of the water level was measured with respect to the elevation of the water in the reservoir. Similarly, the Marcy farm was visited on different occasions, June 3rd, 10th, 16th, 28th, 1977. At all times, the spring in the wetland area was flowing and standing water was noted.

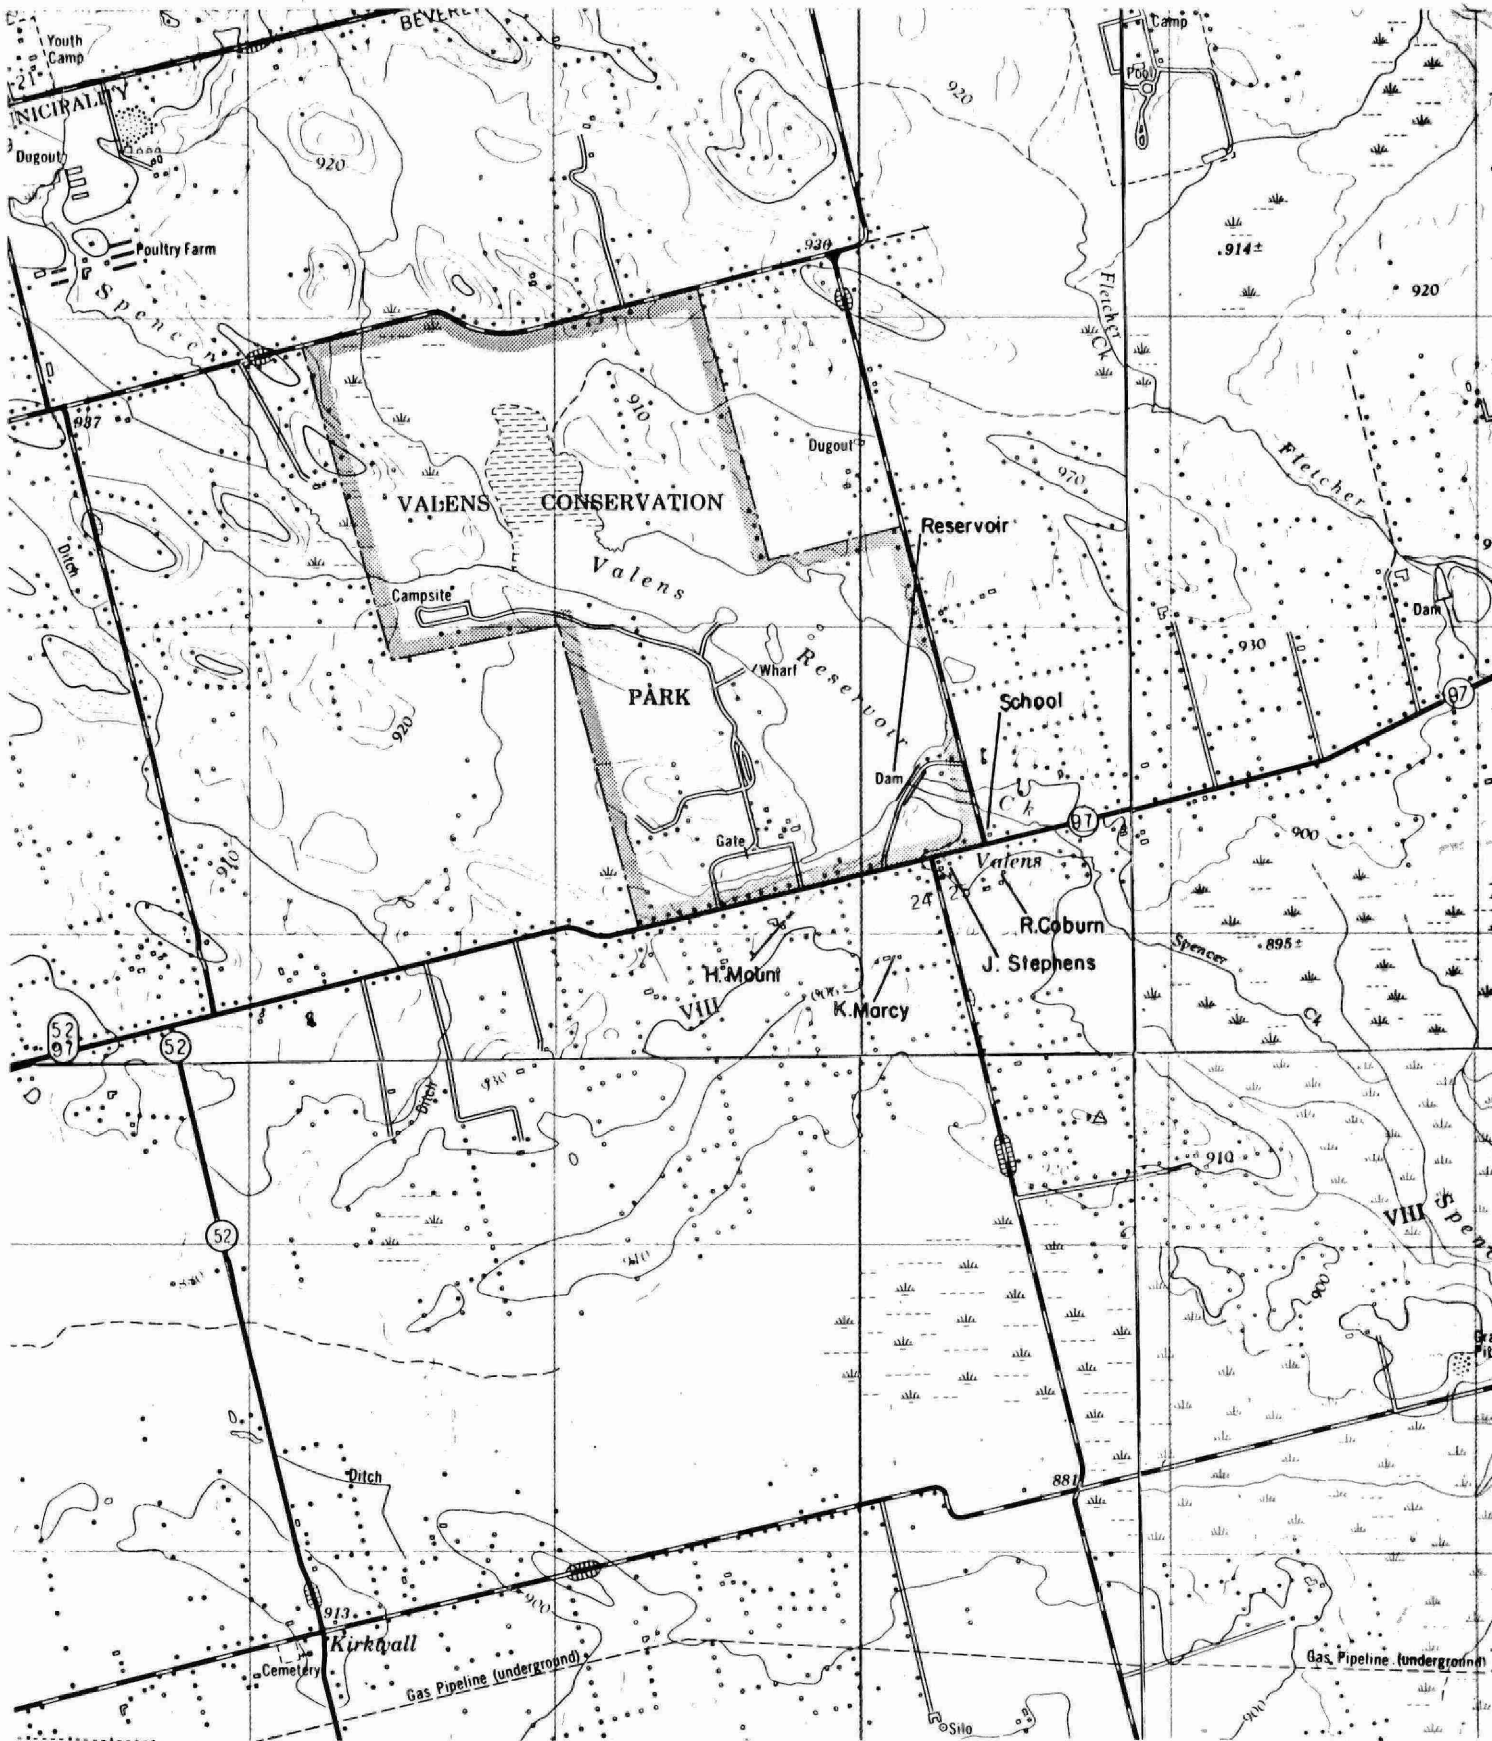
FIGURE 6  
Elevation Levelling Survey Location Map

In order to establish elevation relationships between the reservoir water level, Mr. Marcy's wetland, and other wells in the area, a levelling survey was performed (Figure 6, Locations). All elevation measurements were taken relative to the concrete spillway elevation of the Valens Dam. Mr.

John Coates of the H.R.C.A. provided our office with the elevation of 901.0 feet for the spillway on the upstream side of the dam. The elevations measured are summarized in Table II.

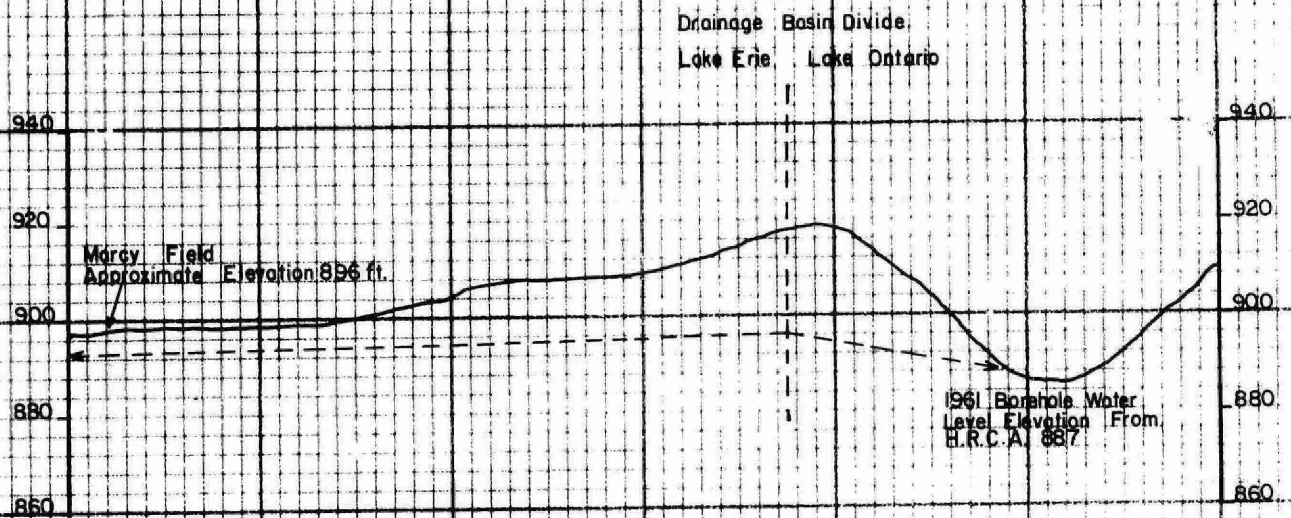
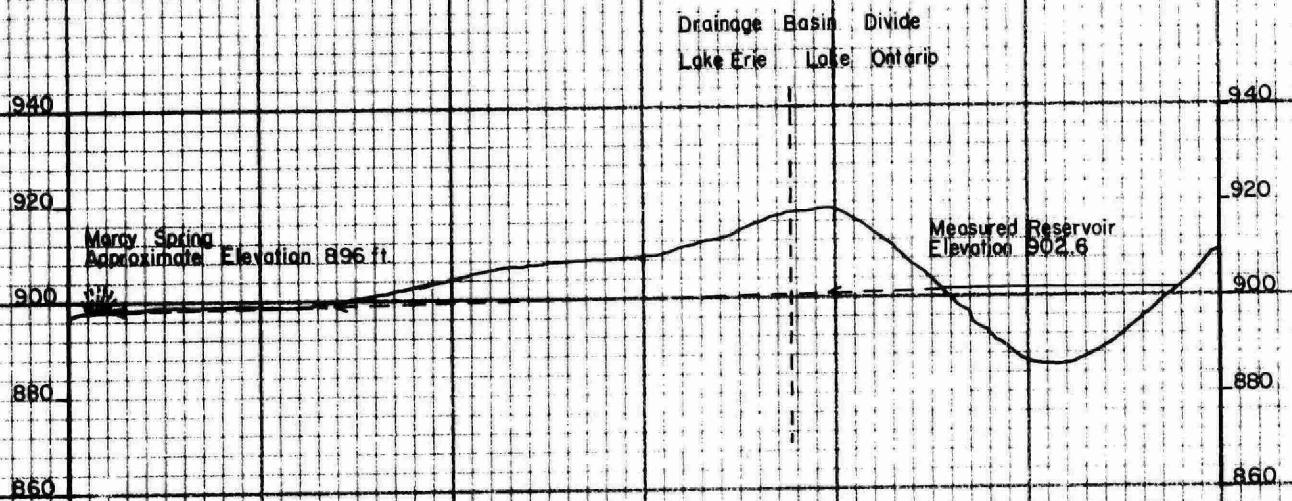
FIGURE 9

Simplified Graphic Simulations Of Suspected Water Table Ground Water Flow Systems Prior To And After Reservoir Construction

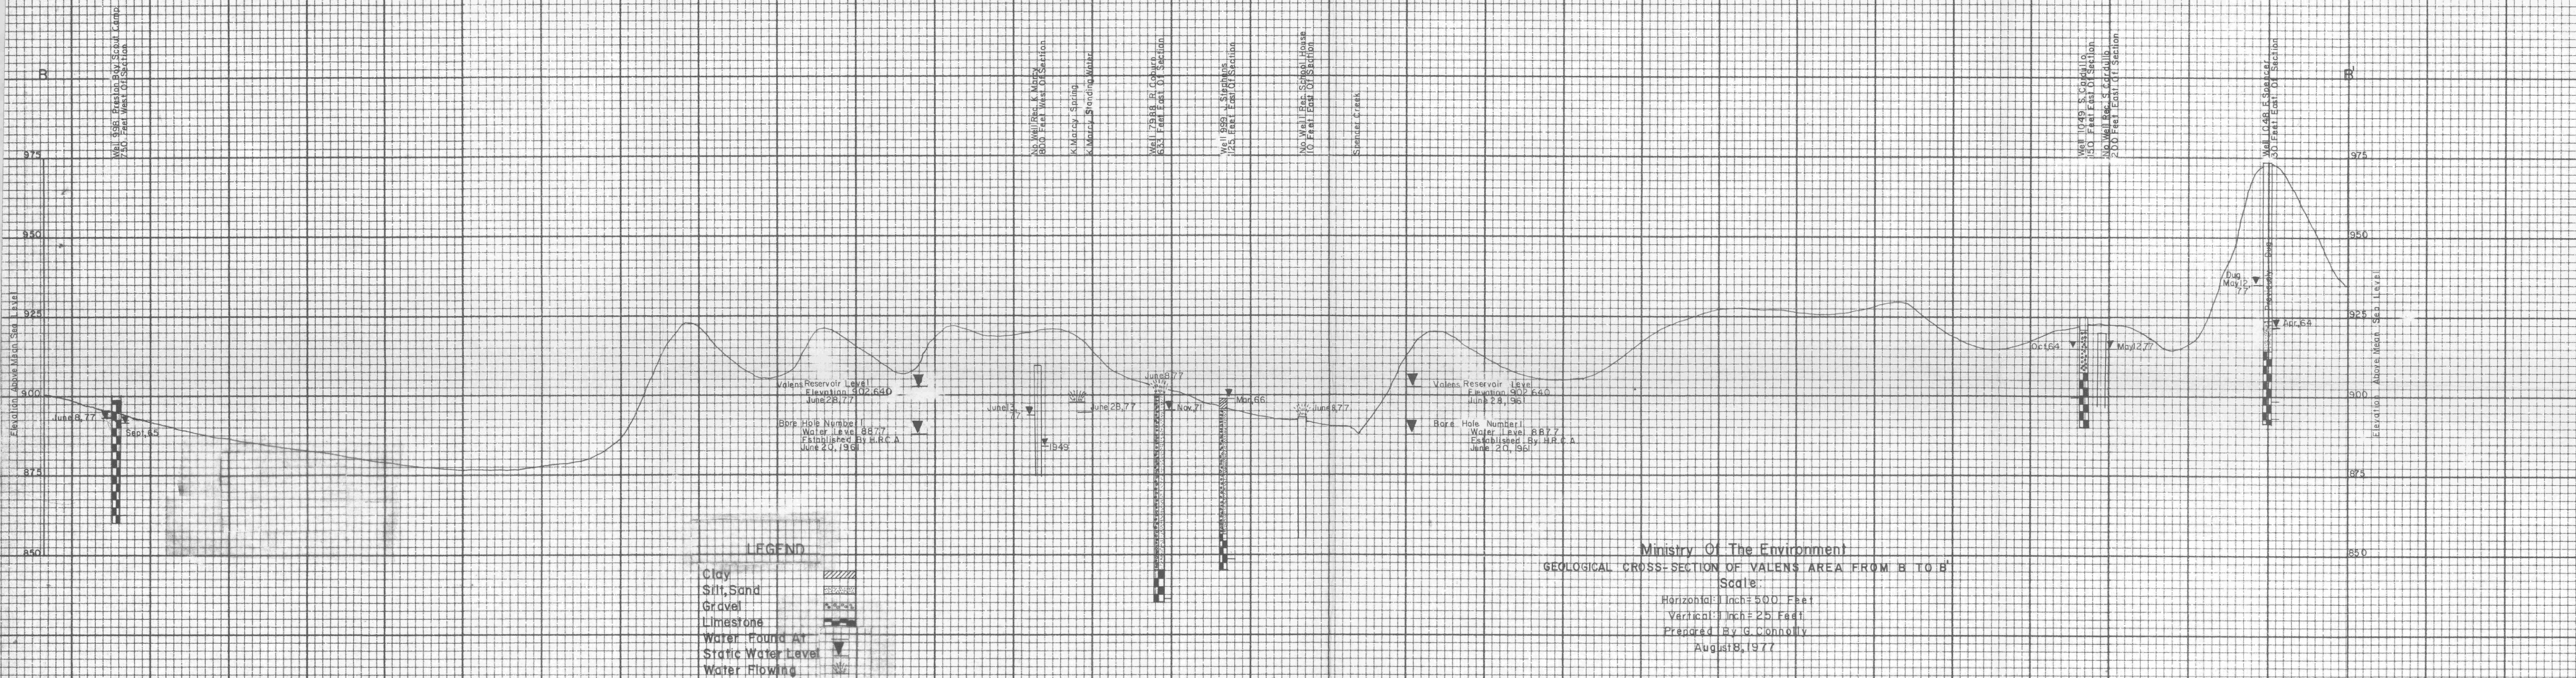
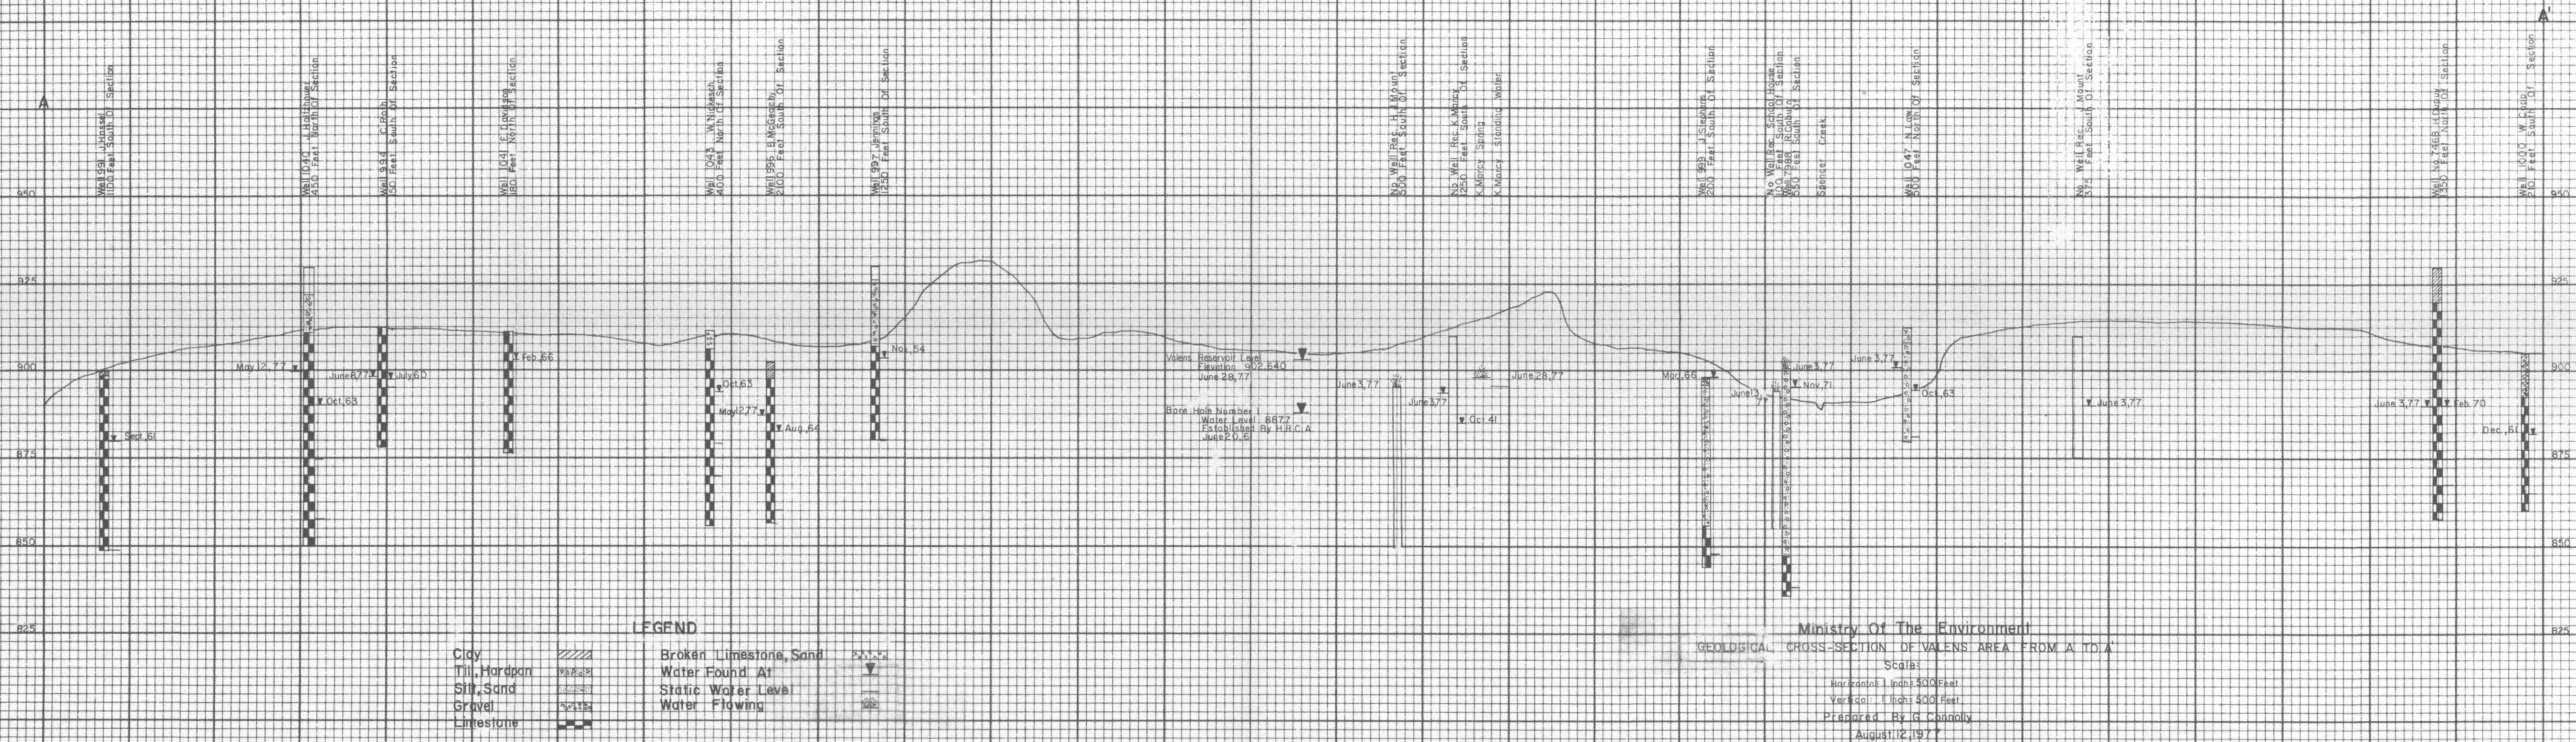
Two hydrogeologic cross sections (back pocket, location shown on Figures 7 and 8, Section A-A', B-B') along Valens Side Road and Highway 97 were prepared incorporating information from water well records, levelling, and water level surveys (well records summarized in Appendix). The cross sections show the extent of the Moffat Moraine and the location of the Marcy and Braden/Law farms on the Morainic deposit. A good correlation of the topography and elevation differentials, with respect to the location and water levels of wells and the elevation of the water level in the reservoir, is also obtained. Water table elevations, prior to the reservoir were supplied by the H.R.C.A. from pre-construction bore hole records. These are plotted indicating elevation differentials with respect to the present reservoir water level.
